IMPORTANT PRODUCT INFORMATION

Product: VersaPro™ Programming Software Release 1.10

GFK-1671E

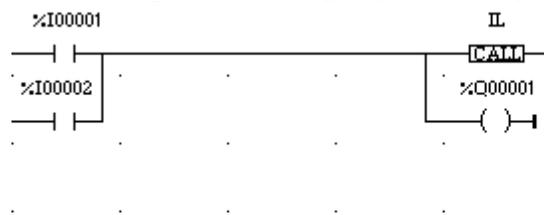
1. VersaPro 1.10 has additional syntax checks to catch errors that were not detected in the previous version. This means that programs that previously compiled in VersaPro 1.00 without errors may have errors when using VersaPro 1.10. If this occurs, you can double click on the error message in the Information Window to navigate to the error. For example the following rung would compile in VersaPro 1.00 without error:

However, this type of construct should not have been allowed because power flow around a function block is not allowed in the 90-30 and VersaMax PLCs. This type of construct should be converted to the following structure to achieve the same functionality:

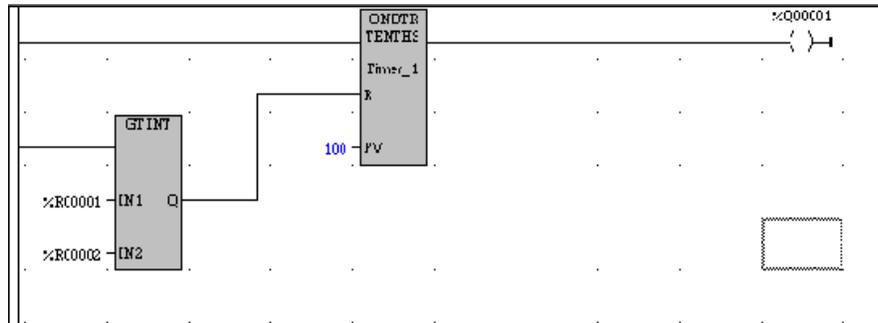
- In some cases VersaPro 1.00 allowed the Boolean output of a function to be used as a power flow input to another function. This is considered an illegal construct which is now being flagged as an error in VersaPro 1.10. An example is shown below:

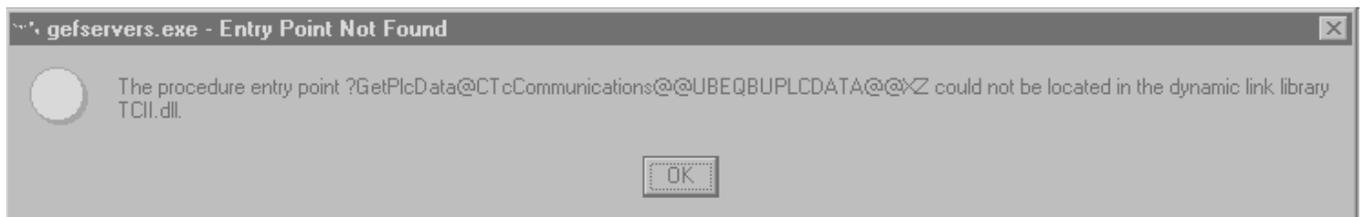
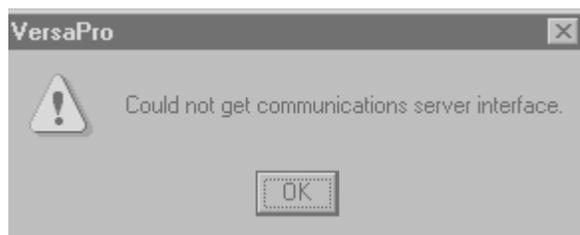
1. **After installing VersaPro 1.10 and then subsequently installing VersaPro 1.00, 1.01 or 1.02, you may receive the following error during the installation process:**

In addition, you may not be able to connect to PLCs after the installation completes and the following error message may appear.

Resolution: A VersaPro 1.10 user wishing to install VersaPro 1.0 can avoid this problem by following these steps:

- a. **Uninstall VersaPro 1.10:** In the Windows Start menu, select Programs\GE Fanuc Software\VersaPro\Uninstall. You can also open the Control Panel's Add/Remove Programs, then select "VersaPro 1.10" for removal. (Uninstalling VersaPro 1.10 by letting the VersaPro 1.0 installer perform the uninstall should be avoided.)
- b. After the uninstall, shutdown and restart the computer.

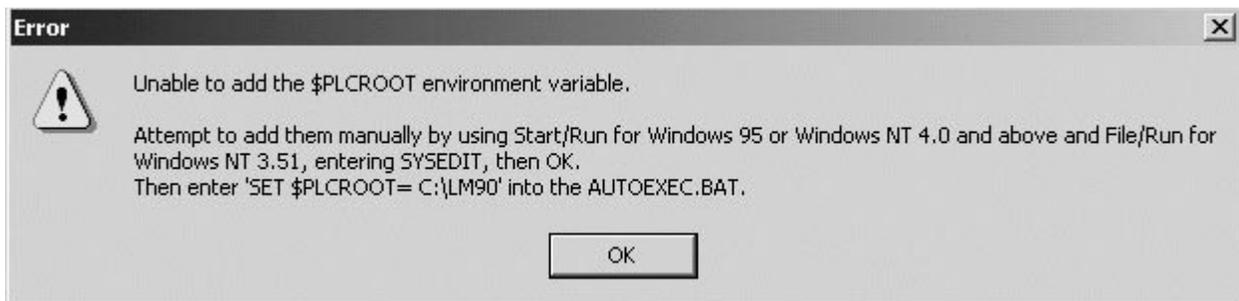
3. **Logicmaster 90-30 Version 9.02 provided on the VersaPro 1.10 CD is not Windows 2000 compliant.** When installing Logicmaster 90-30 Version 9.02 with the Windows 2000 operating system, you will get the following error:

Even though this message occurs, Logicmaster appears to work correctly, but it cannot be guaranteed.

Resolution: Logicmaster should be installed on a PC that supports the Windows 95, Windows 98 or Windows NT operating system.

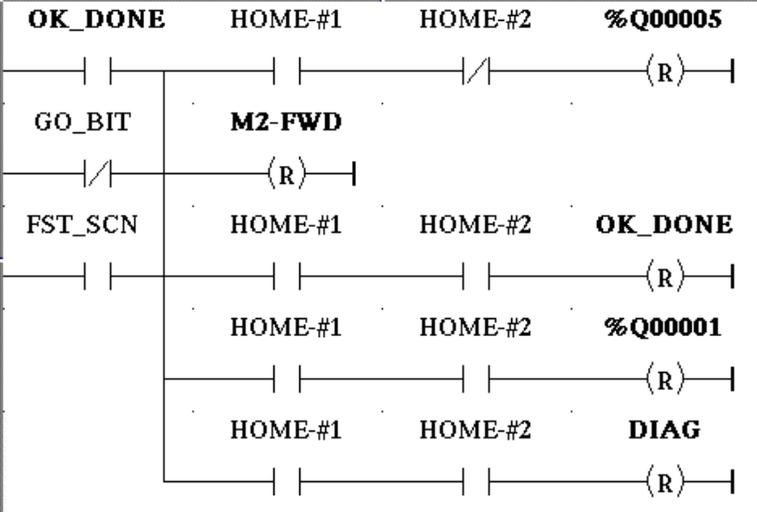
ID	Description
CR71941/ CR71940/ CR71976	<p>Control Version 2.20 VersaMax Configurations can't be imported into VersaPro.</p> <p>Details: Control Version 2.20 VersaMax folders can't be imported into VersaPro.</p> <p>Resolution: Control VersaMax folders should first be opened with Control Release 2.3 and then saved. The updated folder can then be imported into VersaPro.</p>
CR73144	<p>Invalid Program after import and modification of Series 90 Micro LM90 folder.</p> <p>Details: A Logicmaster 90 Micro program that contains a vertical wire immediately in front of a single coil will result in the error 0x05F2 - Invalid Program (or too large for PLC) if it is imported into VersaPro, edited, and then stored to the Series 90 Micro PLC. The Series 90 Micro does not support the optimization that VersaPro performs on this structure.</p> <p>Example:</p>

<p>Resolution: The work around is to add an ALW_ON contact in front of any single coil that has a vertical wire immediately in front of it.</p> <p>Example: An ALW_ON contact was inserted in front of the M2-FWD coil.</p>

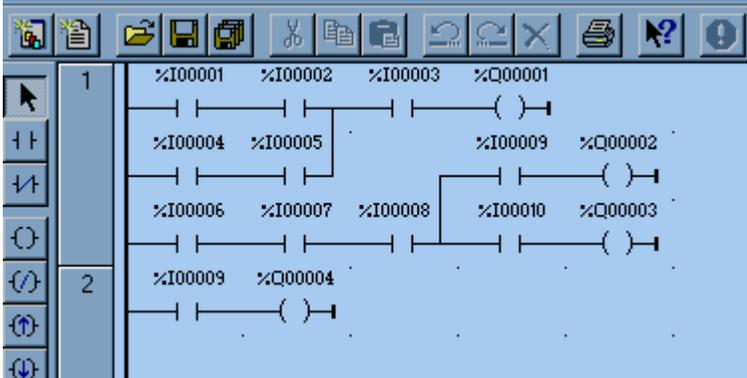
ID	Description																		
CR72315	<p>Three rung ladder recognized as two rung ladder. Details: The ladder below should be recognized as three rungs, not two.</p>

<p>Resolution: Removing the wire between %I9 and %I10 creates 3 rungs. In general, you should avoid overlapping rows of logic. In this particular example, you should move the second rung down one row.</p>																		
CR72316	<p>Continuation contact in LD missing plus sign with some fonts with Windows 95. Details: Open a folder that has rungs with continuation contacts. Change LD display font to Tahoma 10 pt. With focus in block, select File Print, All, OK. The continuation contact in will be missing the plus sign which makes it look like a regular coil. Also, in Options, widen the cell width a little (move the slider bar about 1/4 inch.). With focus in block, select File Print, All, OK. The continuation coil will be missing a plus sign.</p> <p>Resolution: If continuation coils are needed, you should use the default font (MS Serif). The defect does NOT occur with the default font and the fonts listed below:</p>

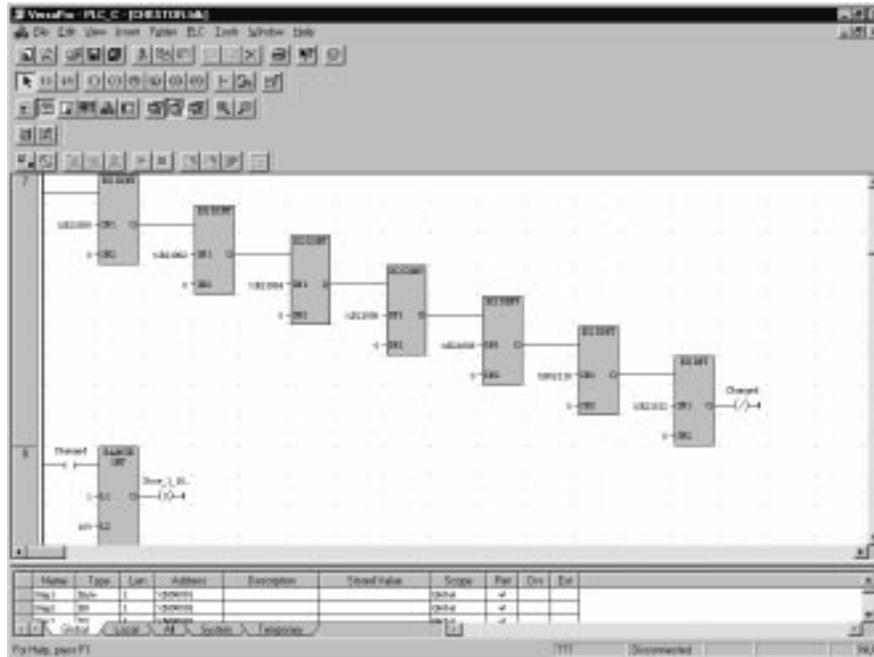
Example 1

CR72929	<p>Program can be stored but not loaded back.</p> <p>Details: In the following example (Example 1), the program can be stored but cannot be loaded back because on the load VersaPro tries to put the function blocks in a straight line which causes the last part of the rung to be beyond the 20 column limit. You will see the following error message: "An expression requires too much space and can't be displayed" during the load from the PLC.</p> <p>Resolution: It is advised that rungs be constructed straight across to avoid this issue (see Example 2). If a very long single rung is needed, you should use the continuation coil.</p>
